Report of Structural Integrity Reserve Study

**SEMINOLE SQUARE APARTMENT NO III ASSOCIATION, INC.**

11620 Park Boulevard  
Seminole, Pinellas County, Florida 33772

SOCOTEC Project Number VS233441.1

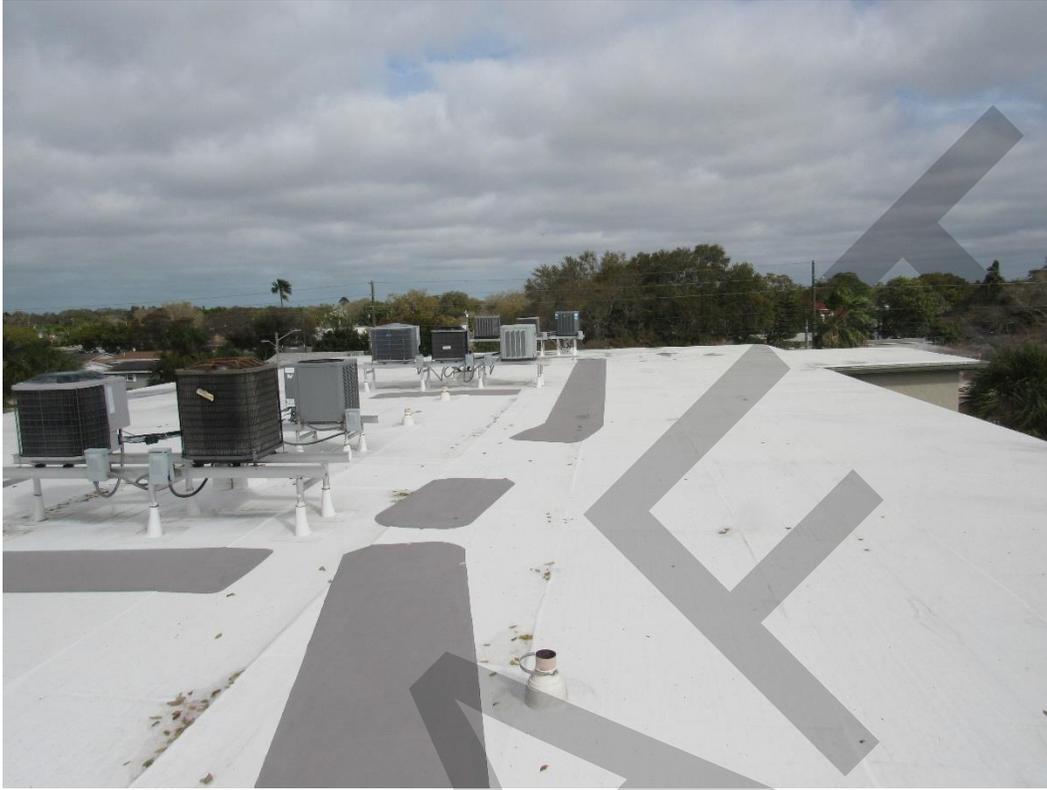
Flat Roof – The flat roofs consist of a single-ply roofing membrane. This type of roof system typically has a useful life of 20 years under normal operating conditions with routine yearly maintenance. At the time of our site visit, the roof was observed to be in fair condition. A reserve has been included for the replacement of the roof.

Overview of roof.

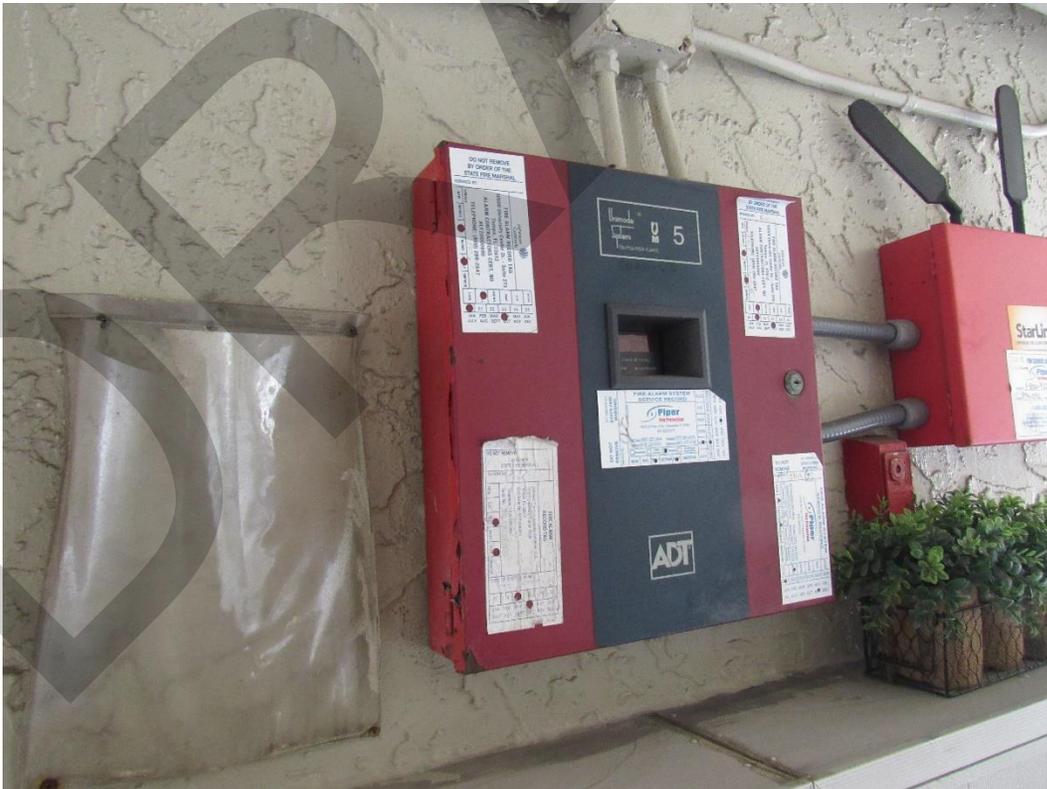
Fire Alarm Control Panel (FACP) and Audio-Visual Fire Alarm System – The structure is equipped with one FACP located on ground level. Numerous audio-visual alarms and fire alarm pull switches are located throughout the building. Typically, these control systems have a useful life

View of FACP.

of 25 to 30 years before requiring an updated system. A reserve has been included for the replacement of the FACP and related equipment.

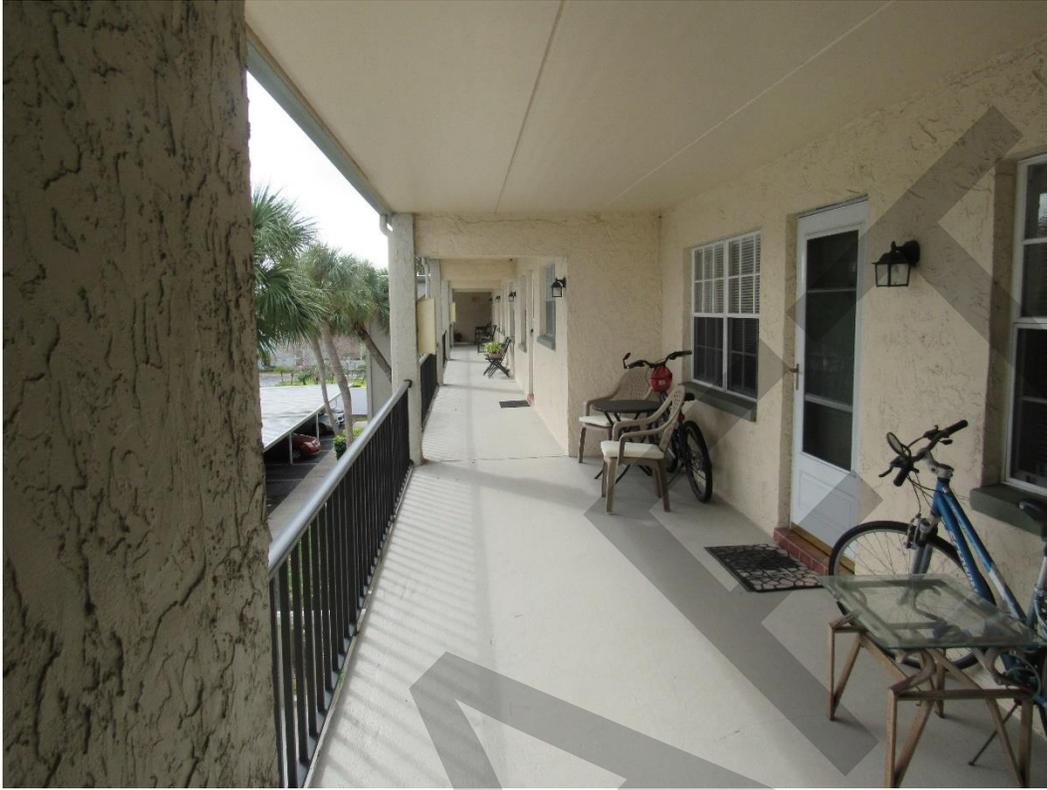
Breezeways and Stairs Waterproofing – It is our understanding that the breezeways are protected with a water-resistant coating. The paint was observed to be in fair condition. A reserve has been included for replacement of the water-resistant paint on a 5-year basis.

Typical walkway.

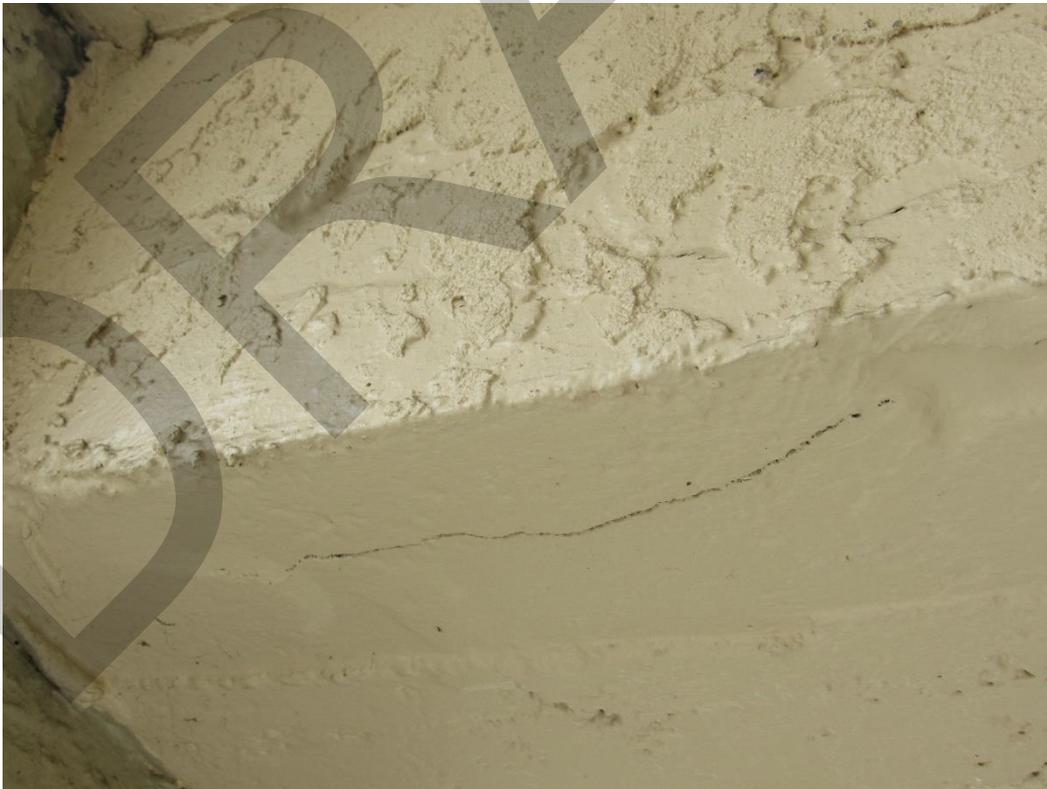
Structural Framing - The load bearing structural members include cast-in-place reinforced columns/beams, and masonry block walls. The concrete floor slabs/decks are conventionally reinforced and supported by concrete beams and columns. Exterior walls consist of masonry block finished with stucco. These types of primary structural members typically have a useful life of 100 or more years when properly maintained/repared. However, during the life of this type of structure it is common for periodic maintenance to be required to correct localized deterioration. Areas of concrete distress were observed at the time of our site visit. The reserve schedule assumes the Association performed the necessary concrete repairs in 2024.

Cracking on walkway beam.

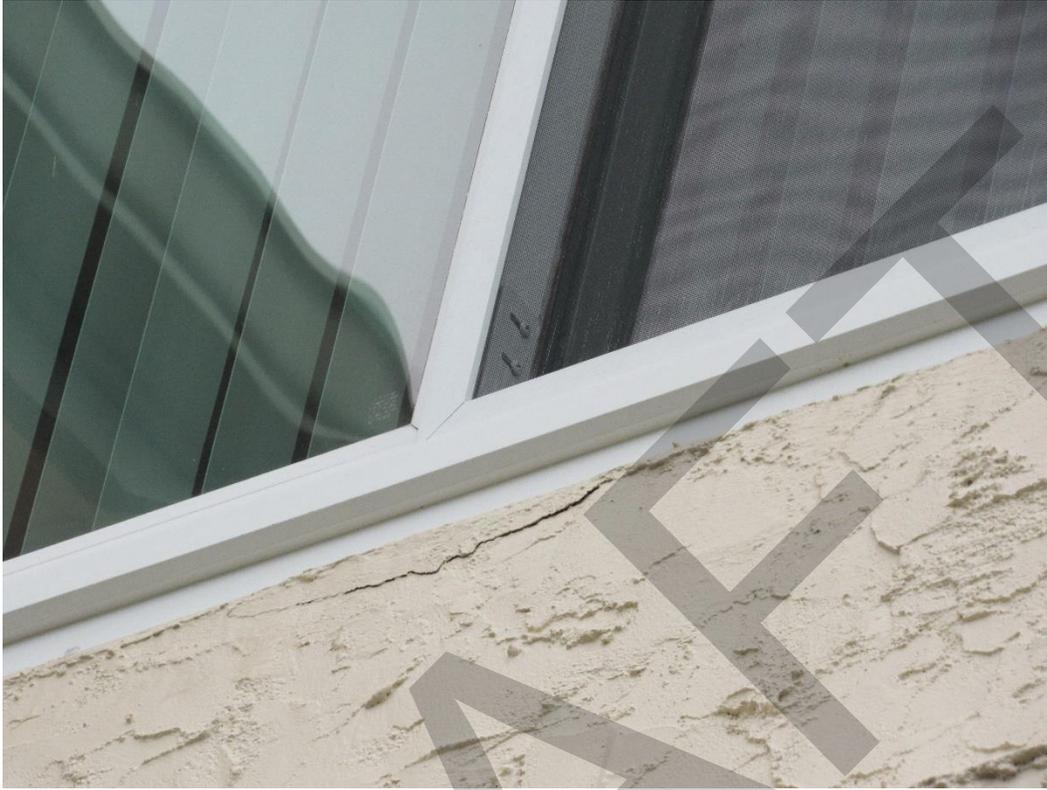
Exterior Painting and Stucco Restoration - It is our understanding the structure was last painted in 2016. The paint was observed to be in fair overall condition. Buildings located in the southwest Florida region are recommended to have their exteriors recoated on a 7 to 10-year basis. A reserve has been included for exterior painting.

Stucco crack on the building's exterior.

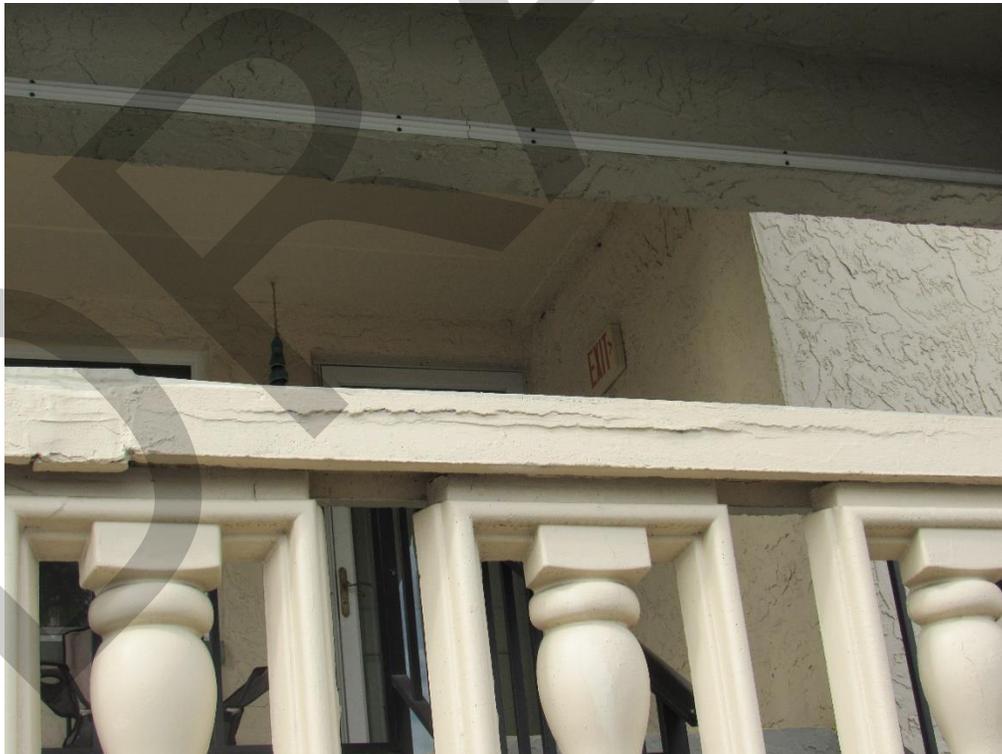
Cracking on concrete railing.
