Don Meyler Inspections

## Replacement Cost Valuation

**Seminole Square Apartments III Association Inc**  
**11620 Park Blvd**  
**Seminole, FL 33772**  
**August 13, 2026**

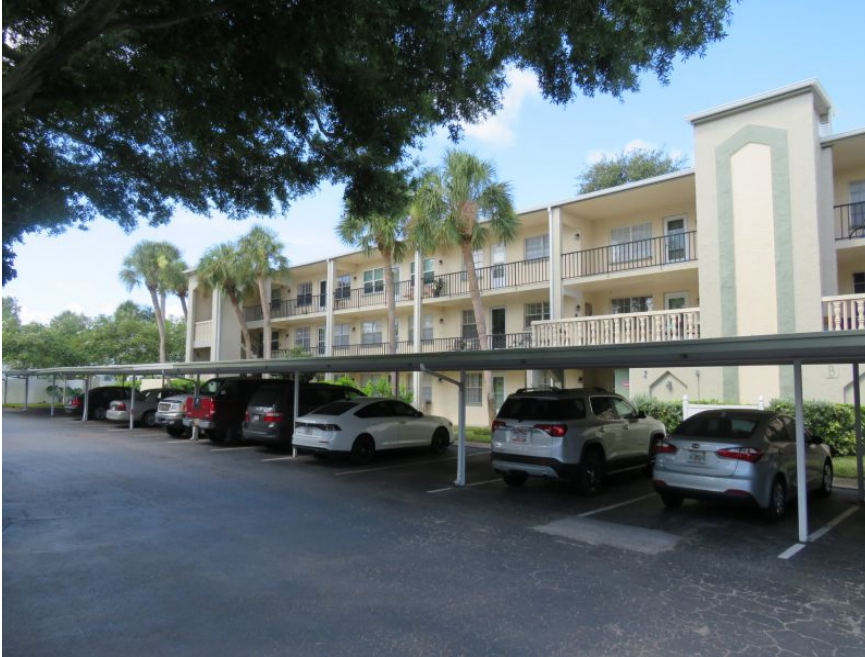
Front Elevation

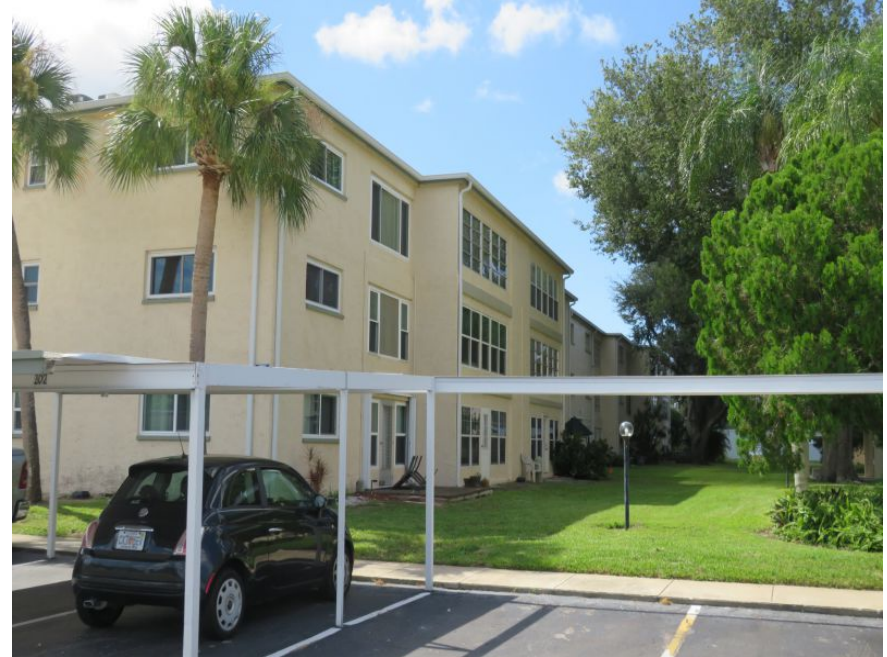
Back Elevation

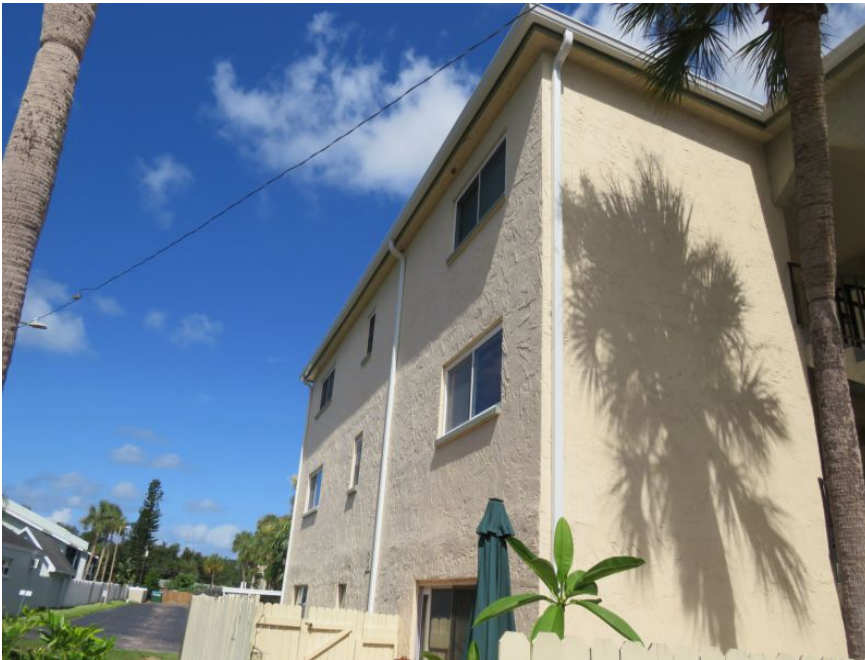
Left Elevation

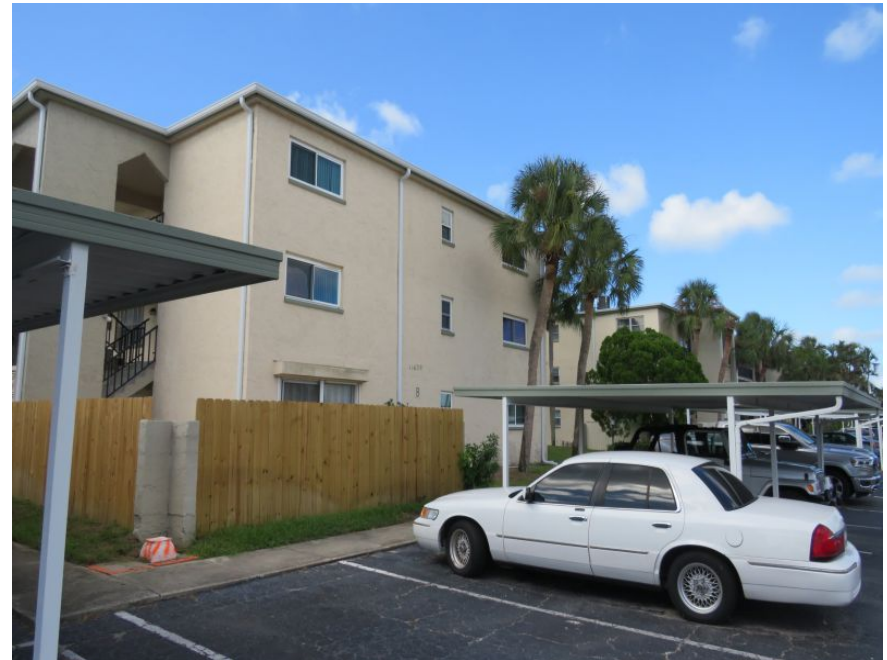
Right Elevation

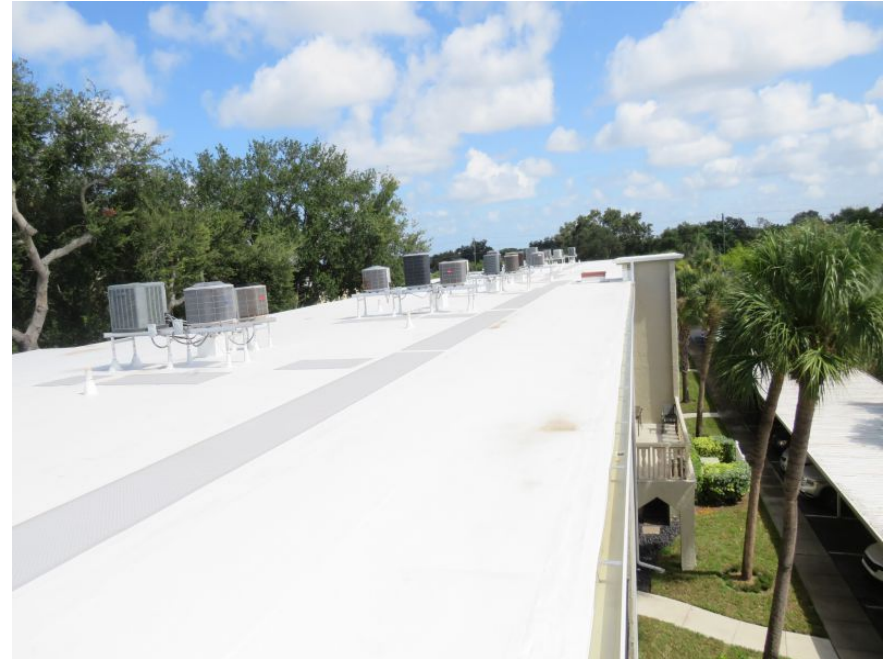
Membrane Roof Covering

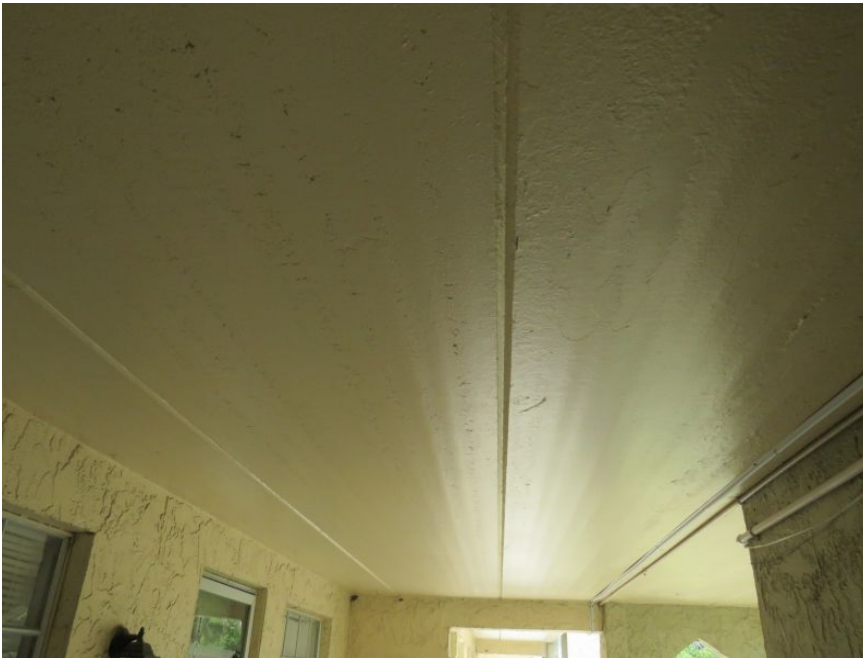
Reinforced Concrete Roof Deck

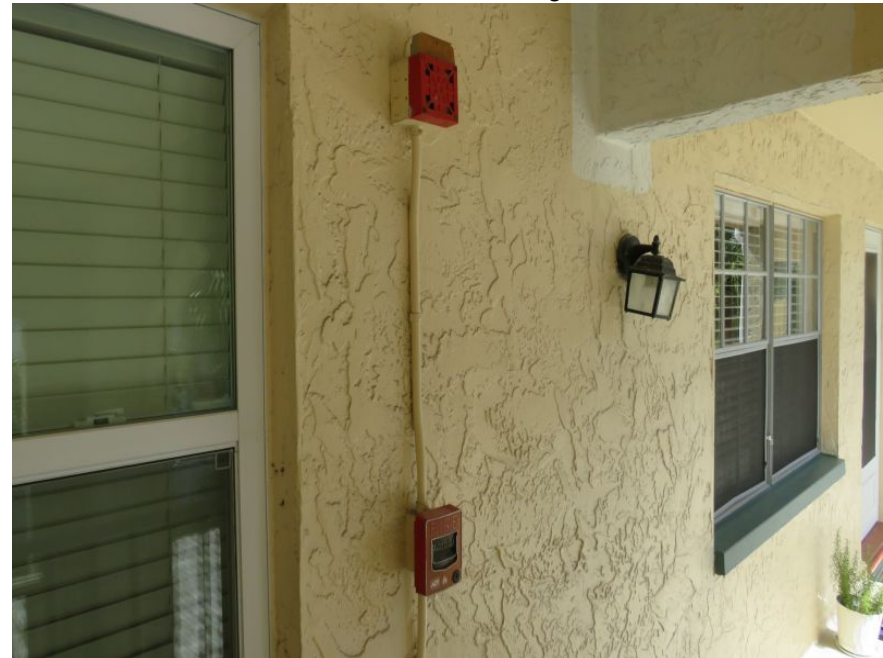
Fire Alarm

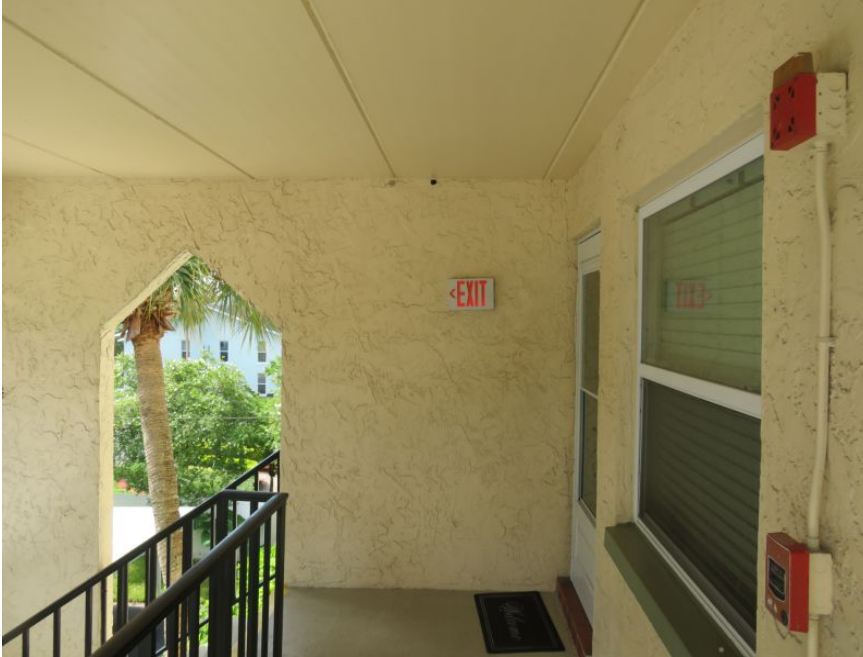
Exit

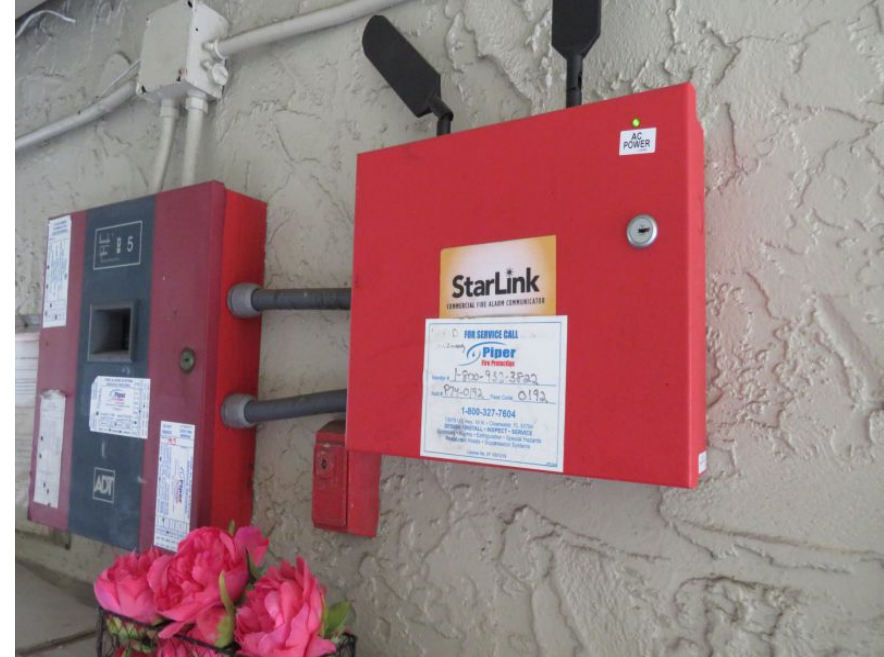
Fire Alarm
