## RECAPITULATION OF MITIGATION FEATURES For Building B, 11620 Park Blvd

# Uniform Mitigation Verification Inspection Form

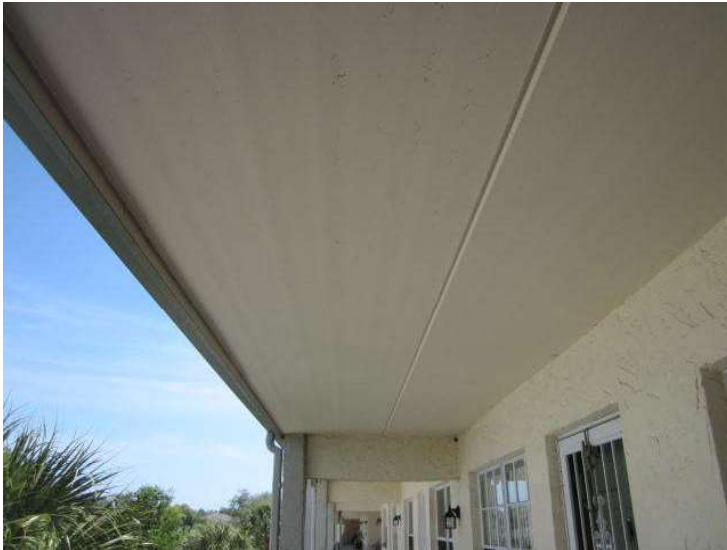
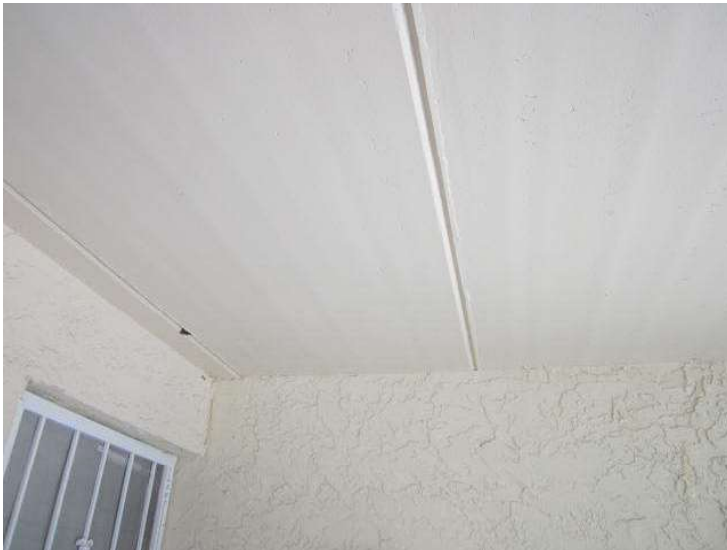
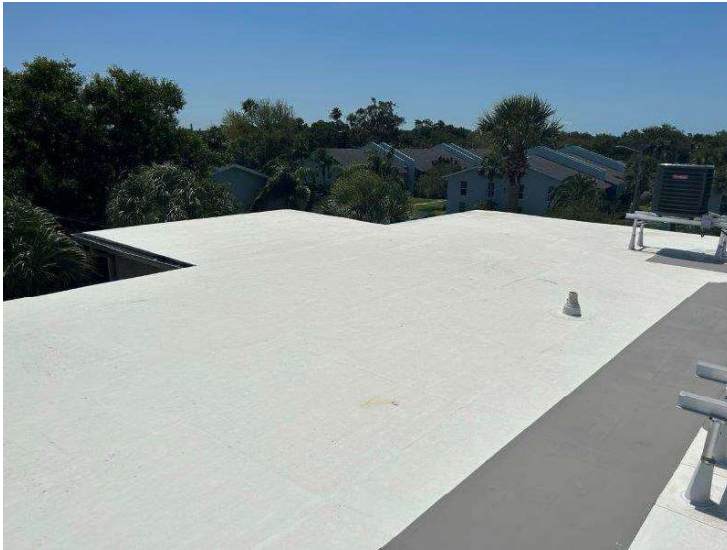
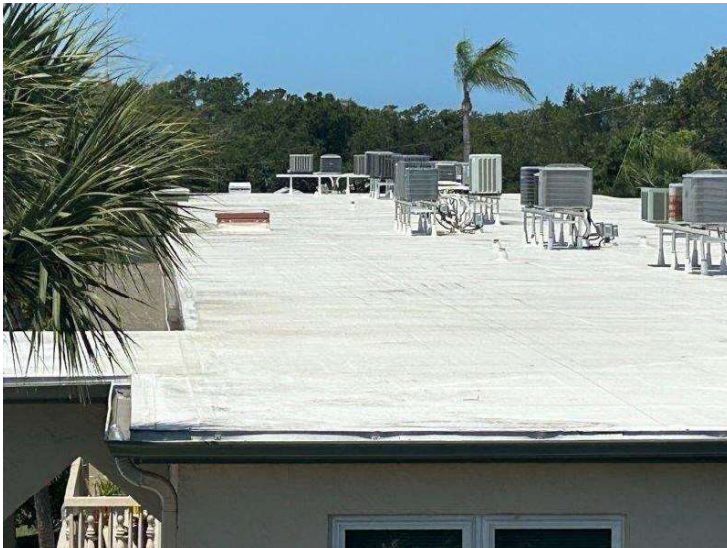
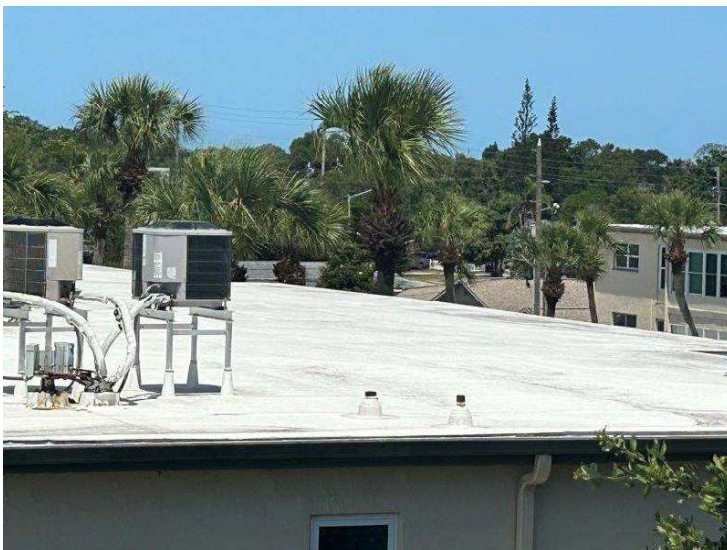
Roof Construction

| <b>3. Roof Deck Attachment:</b><br>Comments: | <b>Reinforced Concrete Roof Deck</b><br>Inspection verified a roof structure composed of cast-in-place or pre-cast structural concrete designed to be self supporting and integrally attached to the wall / support system. |
| <b>4. Roof to Wall Attachment:</b><br>Comments: | <b>Structural</b><br>Inspection verified a roof structure composed of cast-in-place or pre-cast structural concrete designed to be self supporting and integrally attached to the wall / support system. |
| <b>5. Roof Geometry:</b><br>Comments: | <b>Flat Roof</b><br>Inspection verified flat roof shape, refer to attached photographs. |
