# Wind Mitigation Inspection Report

| <b>Address:</b> | 11620 Park Blvd Units 101-310 | | | | | | | | |

# Uniform Mitigation Verification Inspection Form

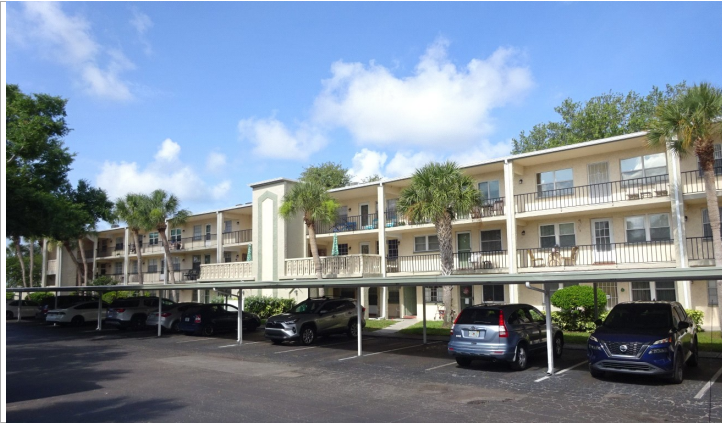
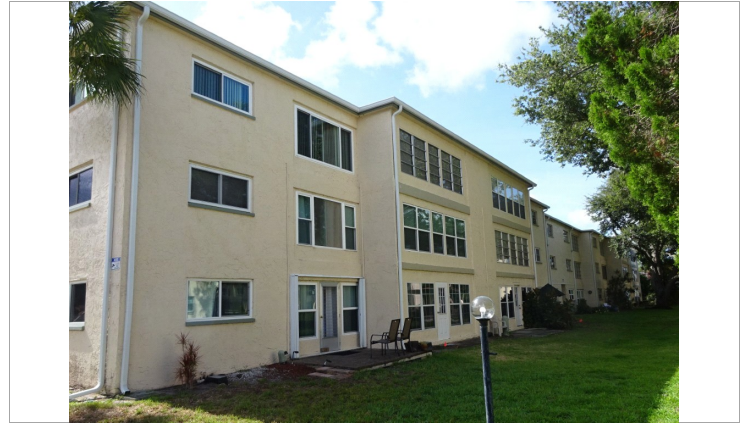
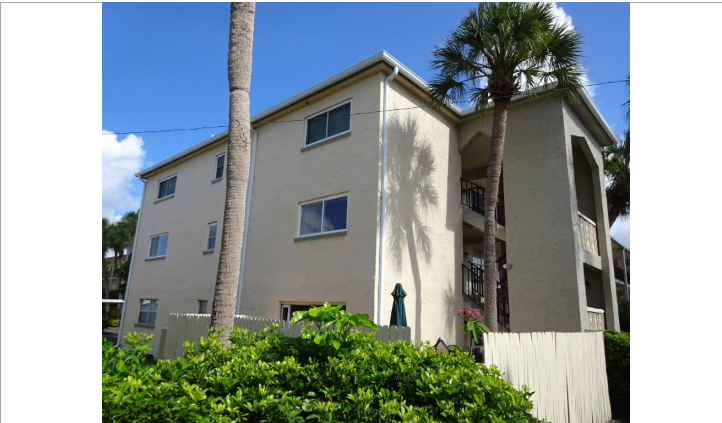
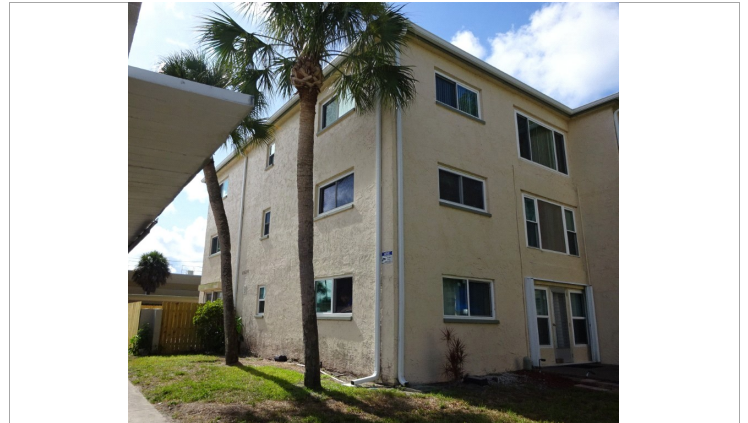
## Elevation and Roof Geometry

☒ B. Flat Roof: Roof on a building with 5 or more units where at least 90% of the main roof area has a roof slope of less than 2:12. Roof area with slope less than 2:12 100% sq ft; Total roof area 100% sq ft

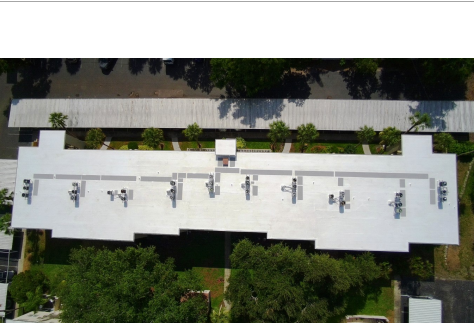
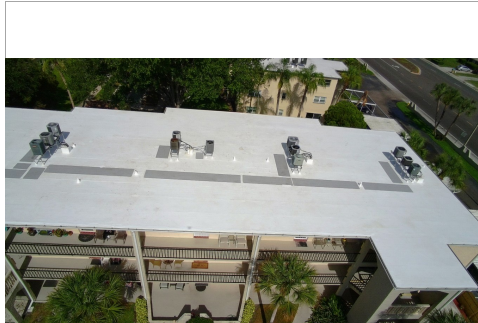
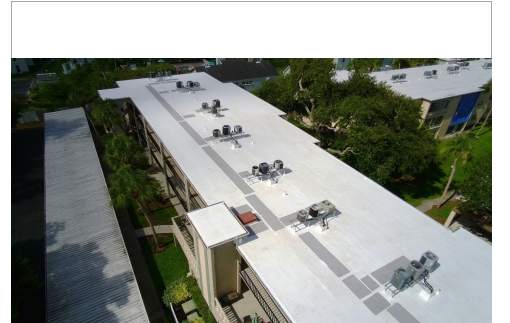
## Roof Covering Types, Roof Slope and Secondary Water Resistance

Permit Date: May 14, 2025

Description: Tear off existing and replace insulation board with a TPO roof system (17862.1) , insulation ( 5968.1), 125 SQS, Flat 0/12

| 4.1 Roof Covering Type: | Permit<br>Application Date | FBC or MDC Product<br>Approval # | Year of Original<br>Installation or<br>Replacement | No Information<br>Provided for<br>Compliance |
|---|---|---|---|---|
| <input checked="" type="checkbox"/> Membrane | May 14, 2025 | CBP26-000106 | _____ | <input type="checkbox"/> |
